## **APPENDIX L**

### Photographs

Appendix L. Photographs taken throughout the study watersheds. The first section of photographs include images captured at representative sites throughout the watersheds. The last section (L17-L22) includes photographs taken of culverts located downstream from discharge monitoring locations. These photographs were taken to help assess how similar (e.g., unobstructed) the culvert openings were prior to each monitoring event. Photographs were not collected prior to the first storm (3/28/00) because a camera was not available at the time (culverts were cleaned just before sampling/monitoring occurred).

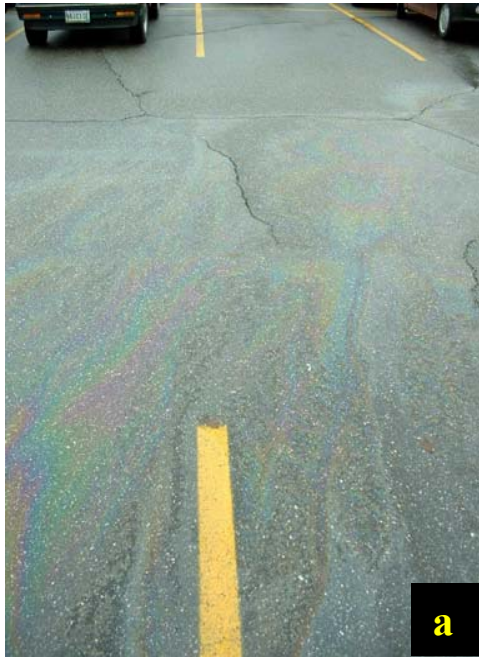
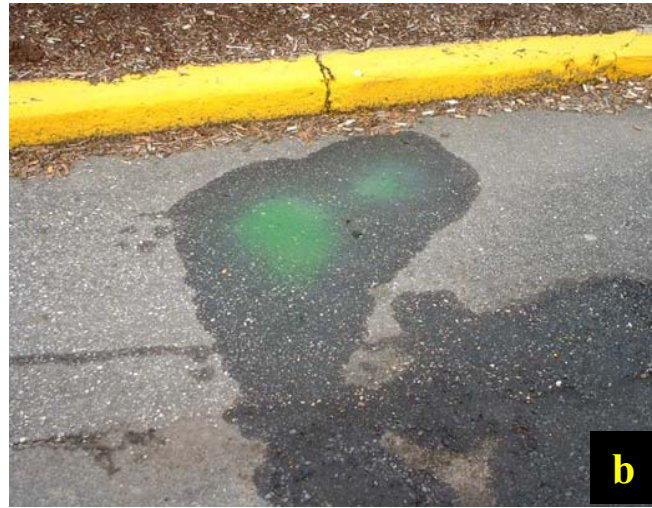
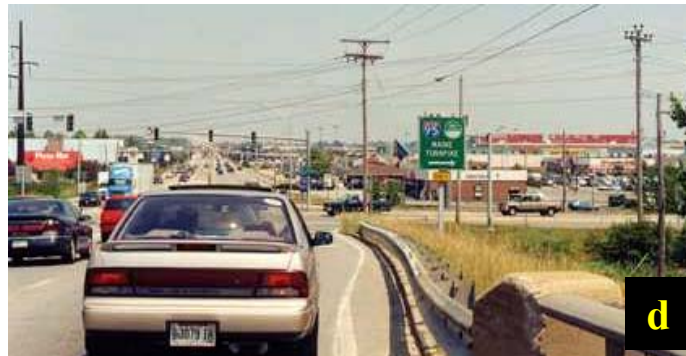
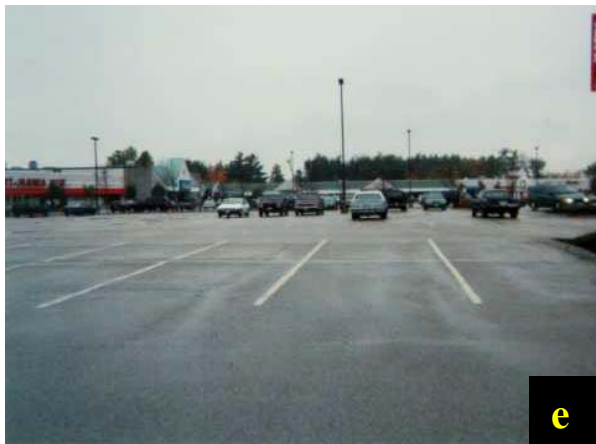
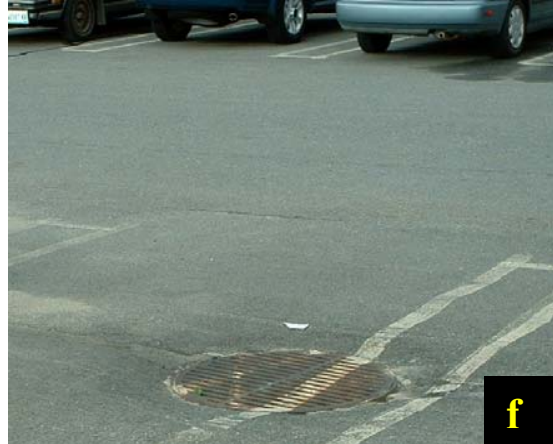
Appendix L-1. Photographs taken of various impervious surfaces and associated stormwater pollution problems: automobile-related petroleum pollution (a); antifreeze (b); parking lots and roads (c,d,e,g); and stormwater drain (f). Photographs taken between 2001 - 2002.

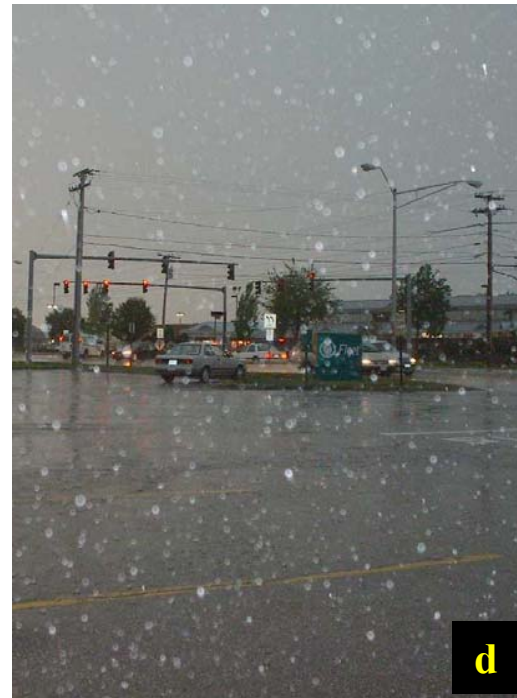
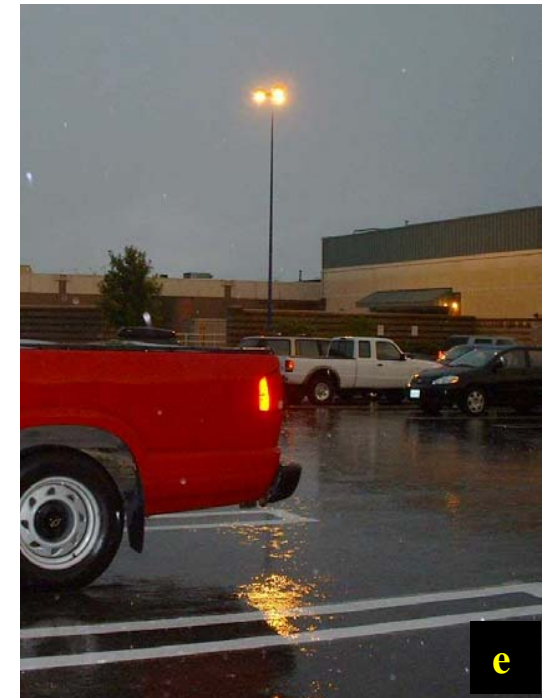
Appendix L-2. Photographs taken on 6/28/00 of impervious surfaces and stormwater runoff in the study watersheds.

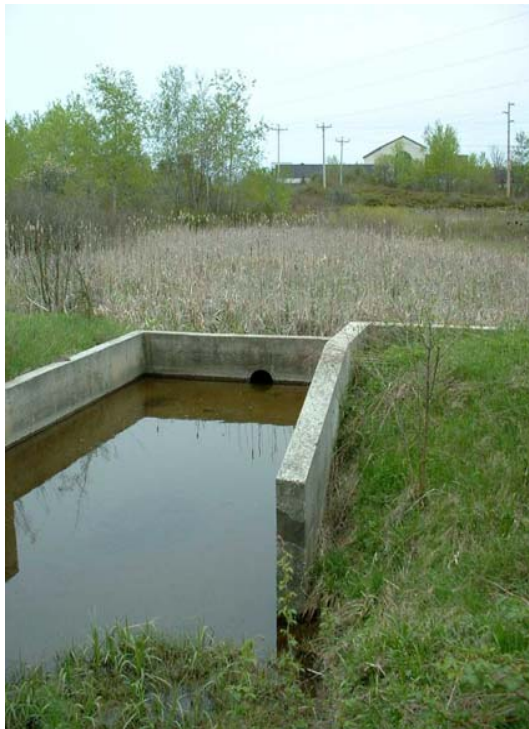
**a**

Appendix L-7. Photographs taken of an in-stream detention basin, dam, and concrete outfall (a), taken on 5/13/02, and portions of LC-M flowing through a golf course between stream mile LC-M-2.3~ and 2.7~ (b-d), taken on 11/16/02.

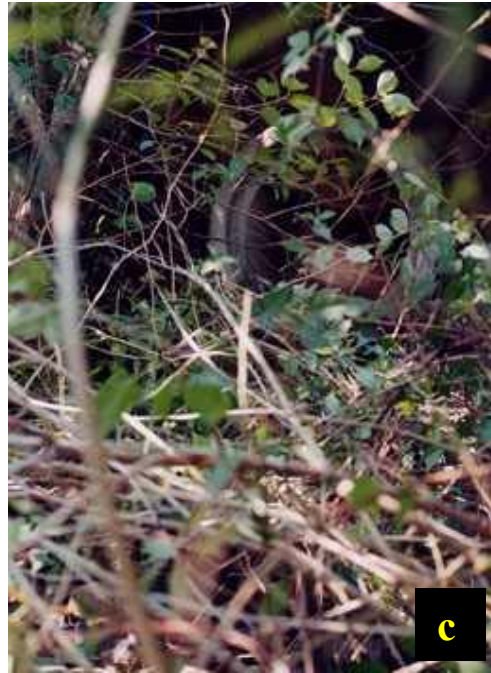
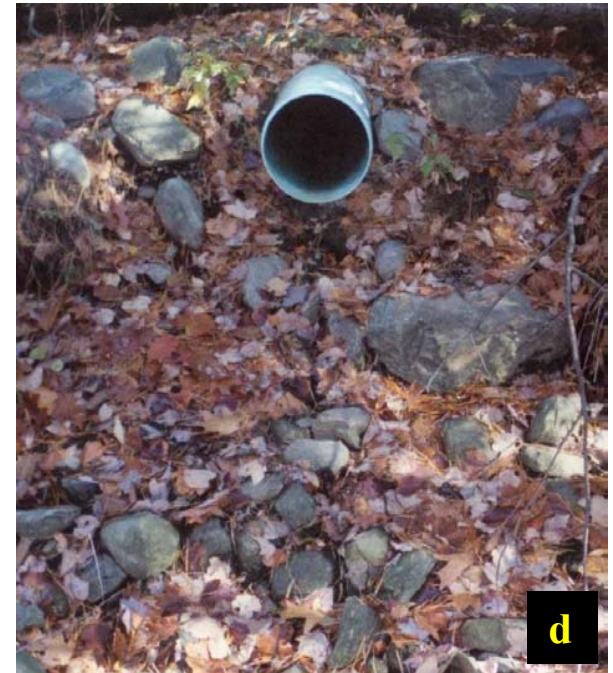
Appendix L-9. Photographs taken near LC-M-0.9~ of: a shaded section of stream (a), a stormwater detention pond and its outfall pipe (b-c), and a detention basin outfall pipe near LC-M-0.65~ (d). Date: 6/12/99 (a), 7/23/01 (b-c), and 11/10/00 (d).

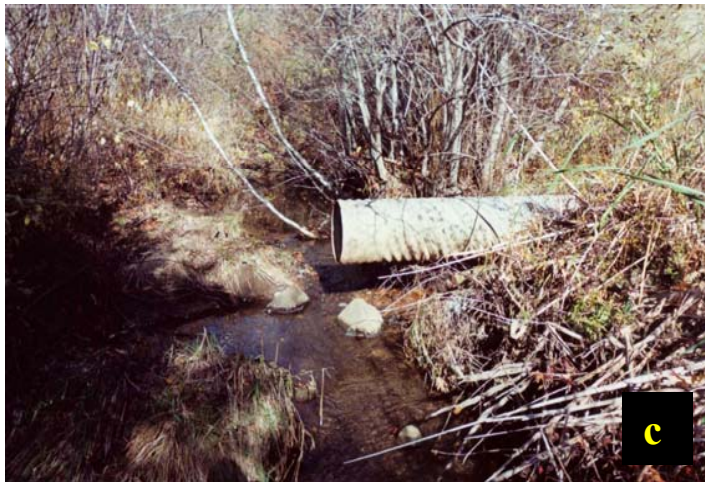
Appendix L-15. Photographs taken of some trash (a), a powerline area (b; *photo is slightly tilted*), a stormwater outfall pipe (c), and a shaded reach (d) at LC-N near stream mile 0.85 (a,b), 0.6 (c), and 0.4 (d).

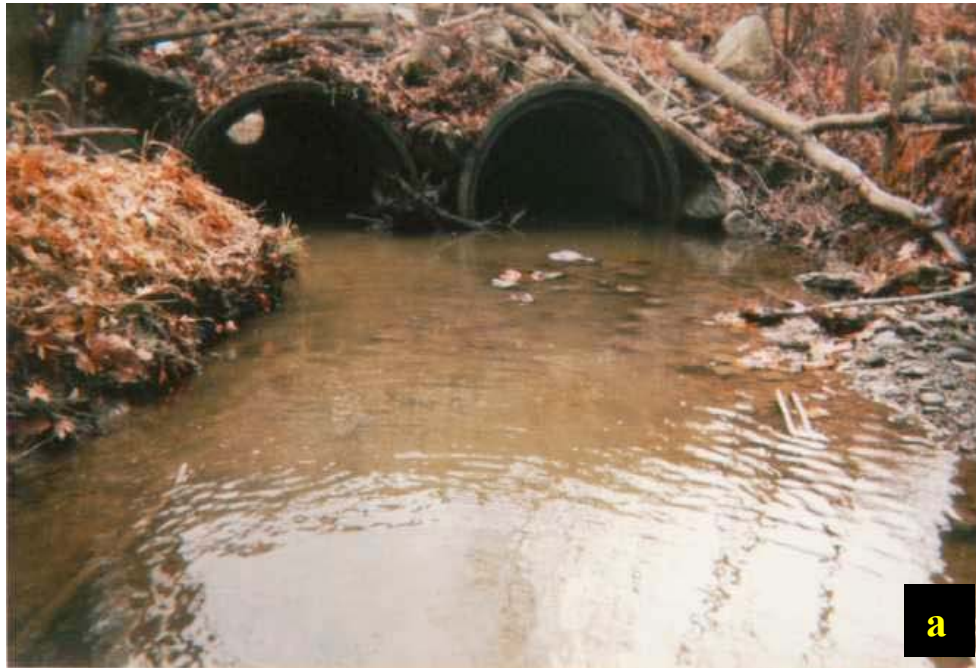
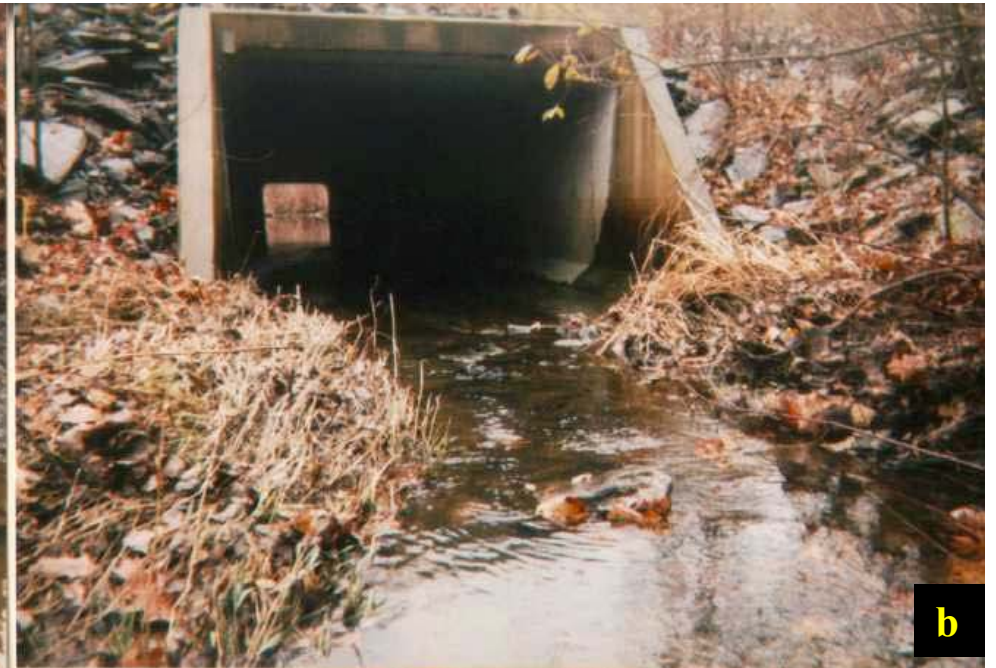
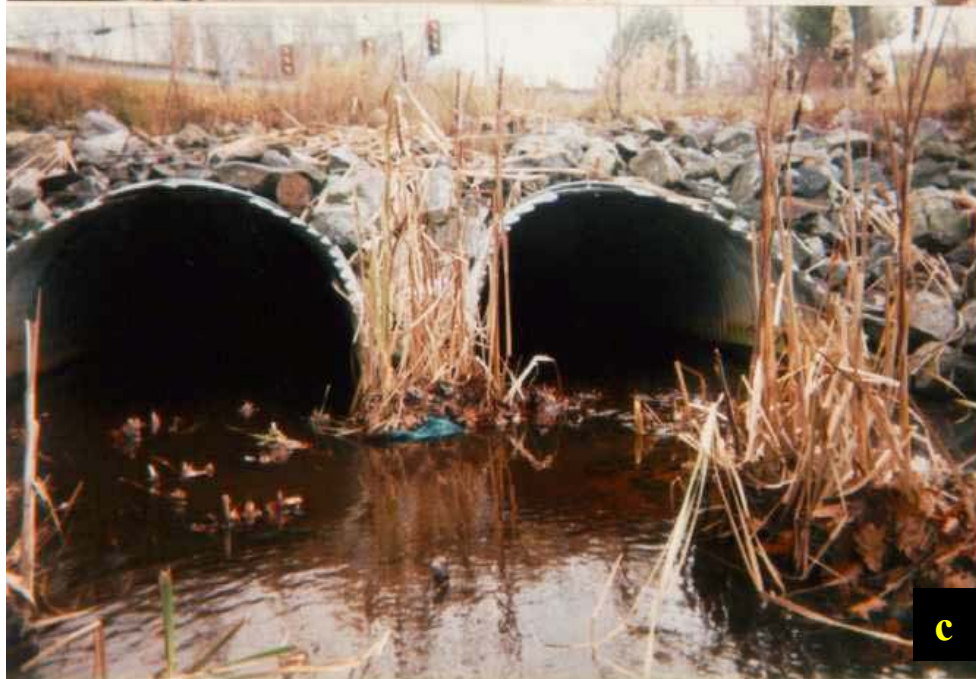
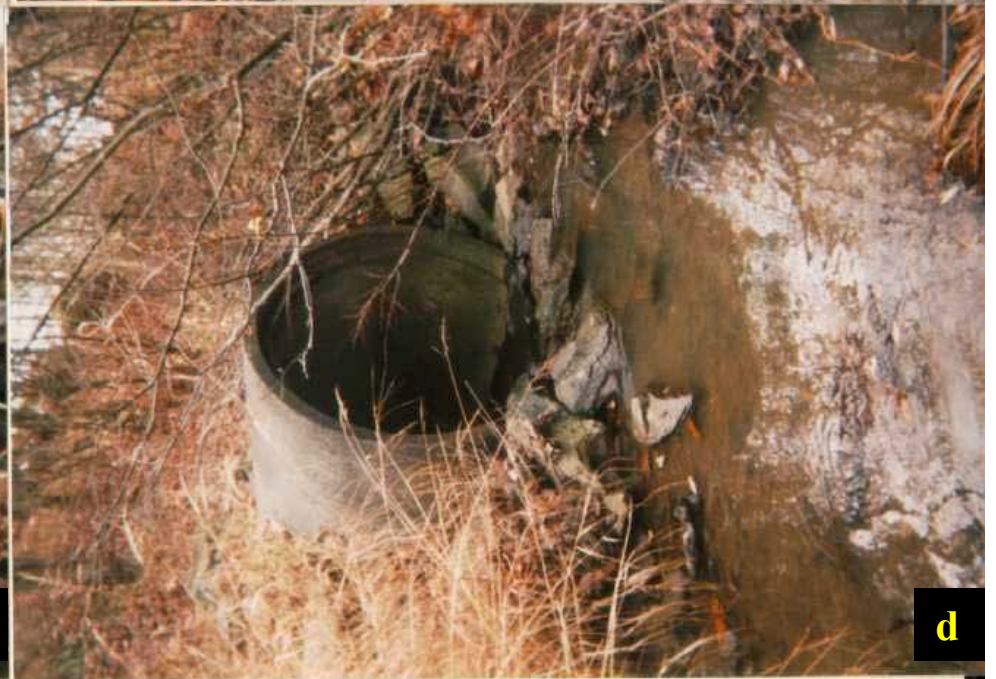
Appendix L-17. Pre-storm culvert photographs taken on 11/10/00 for the first flow-meter calibration event: a) LC-M, b) LC-S, c) RB, and d) LC-N.

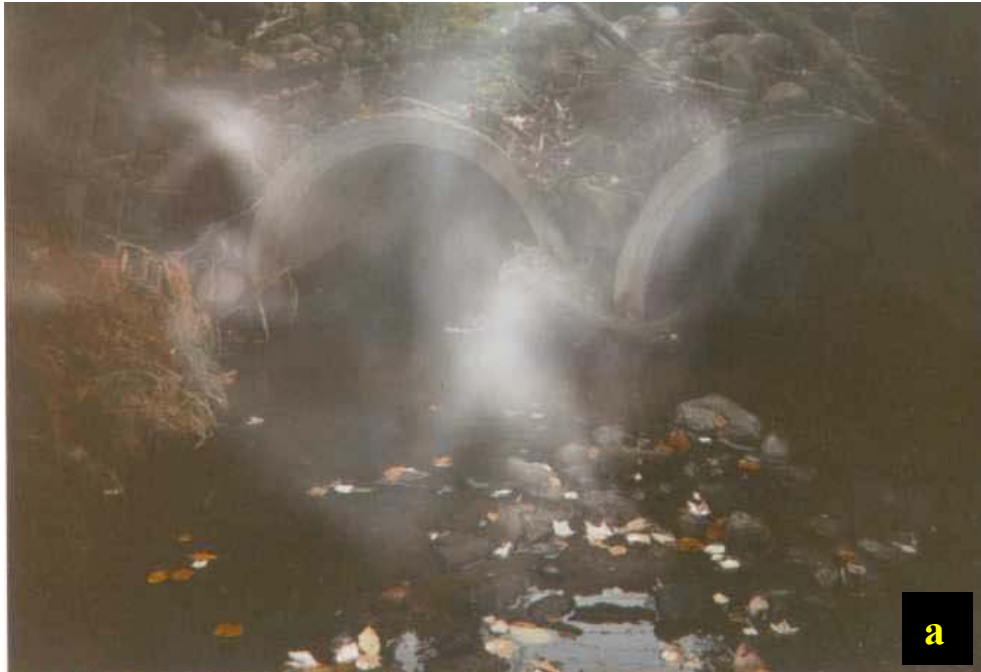
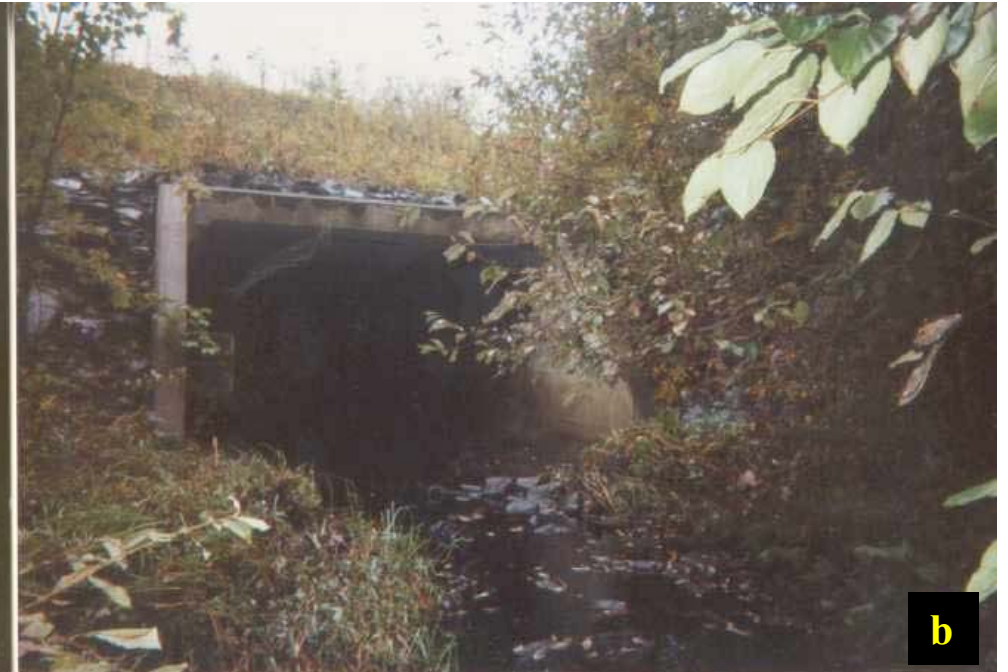
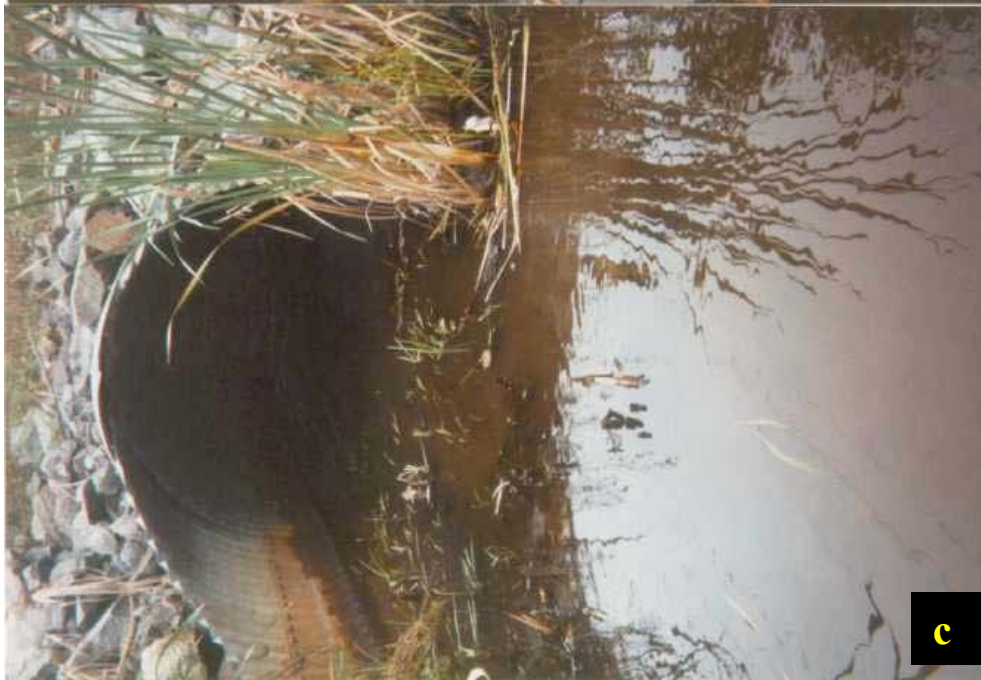
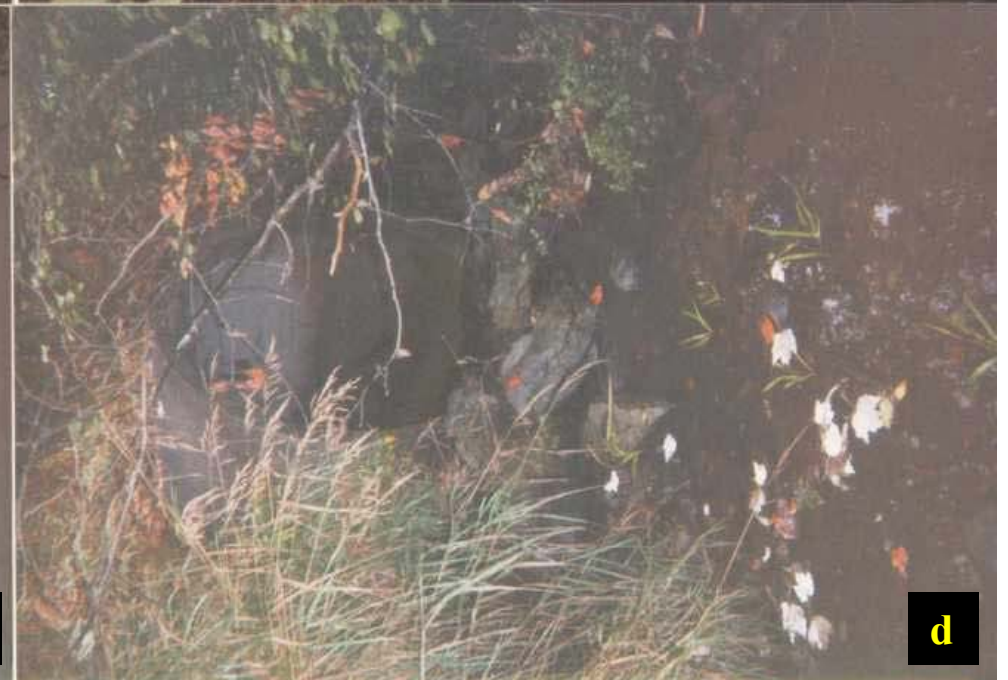
Appendix L-18. Pre-storm culvert photographs taken on 9/21/01 for the second flow-meter calibration event: a) LC-M, b) LC-S, c) RB, and d) LC-N.

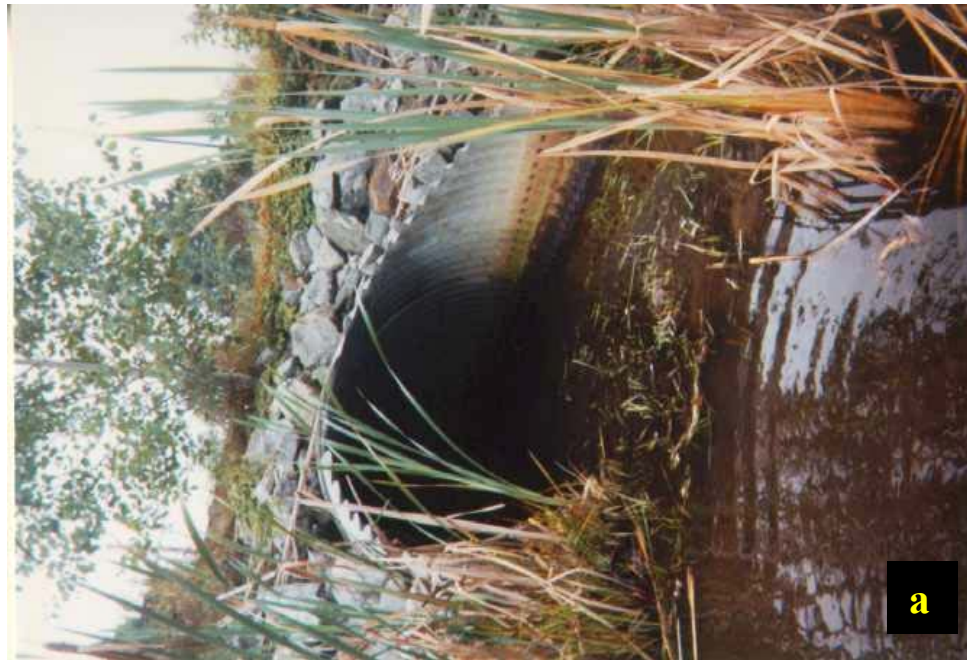
Appendix L-19. Pre-storm culvert photographs taken on 9/21/01 for the second flow-meter calibration event: a) RB (other side of double culvert).

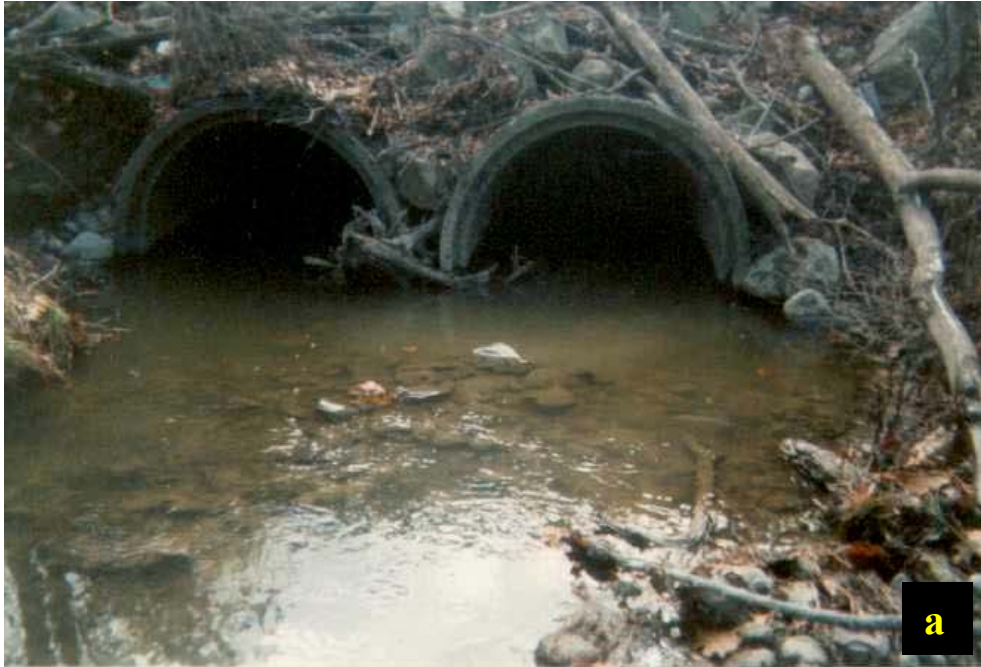
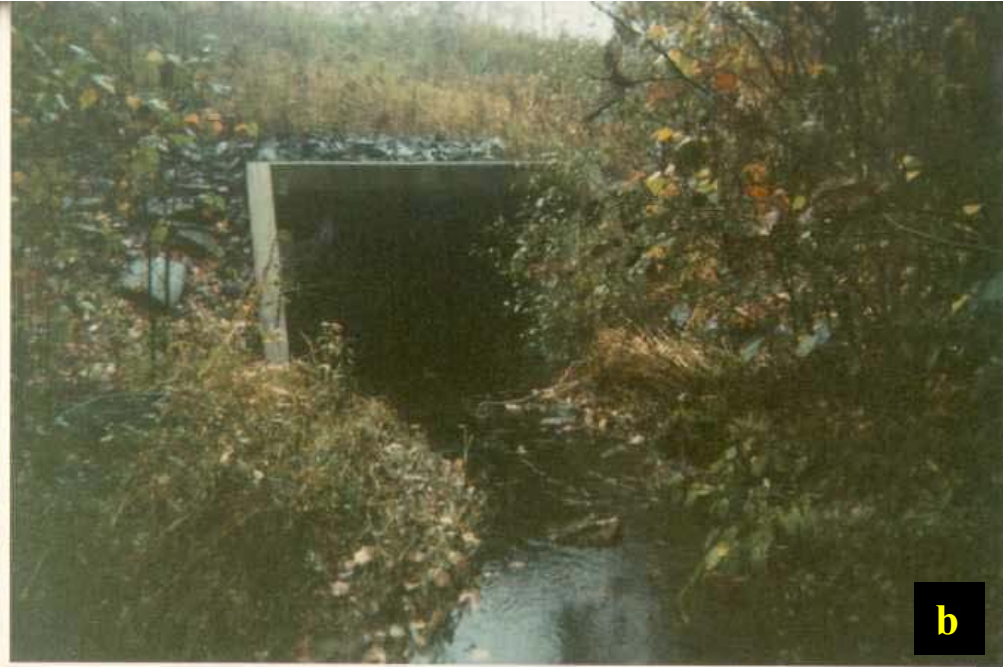
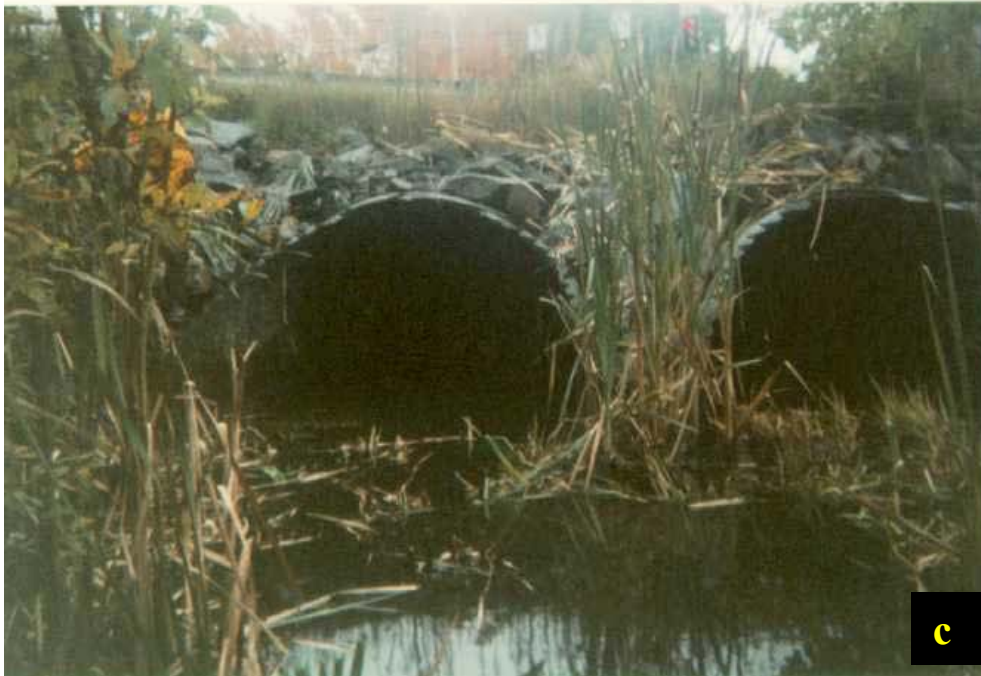
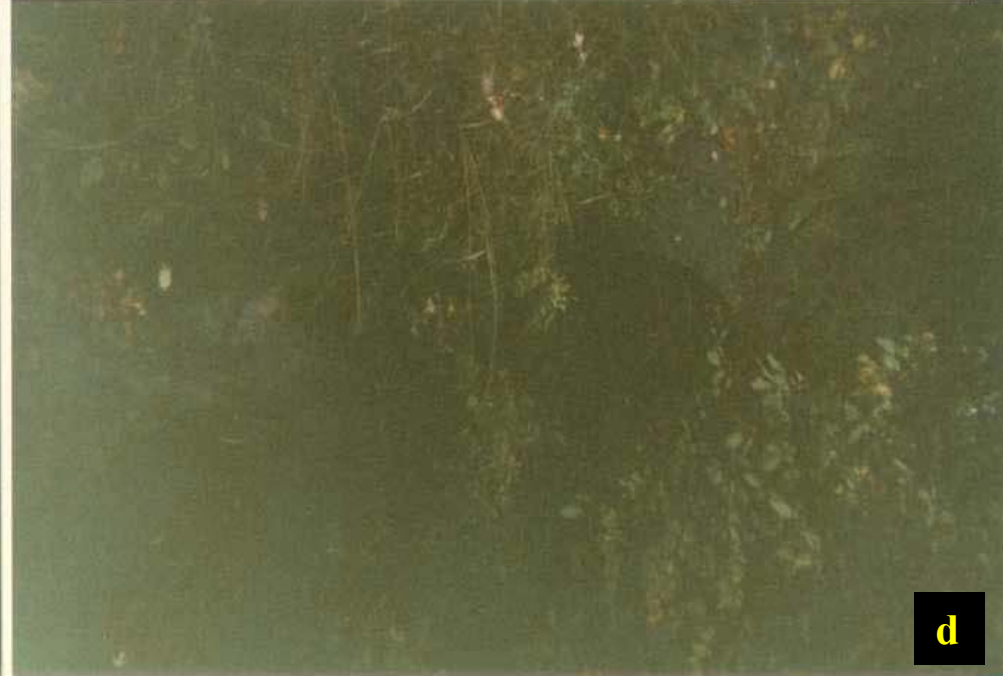
Appendix L-20. Pre-storm culvert photographs taken on 10/18/00 for the second stormwater monitoring event: a) LC-M, b) LC-S, c) RB, and d) LC-N.

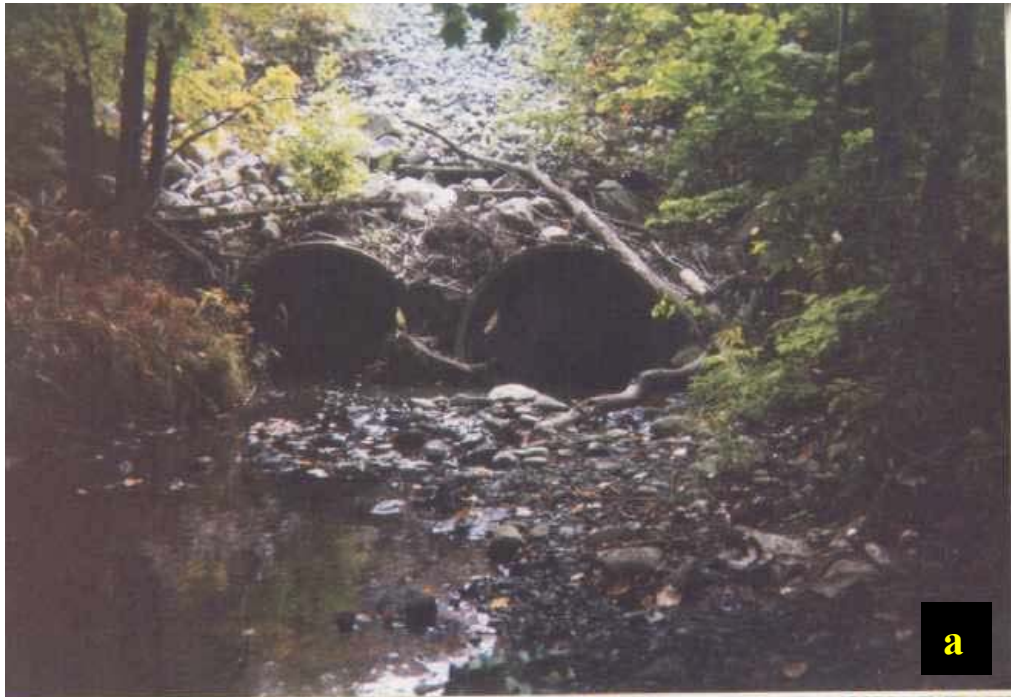
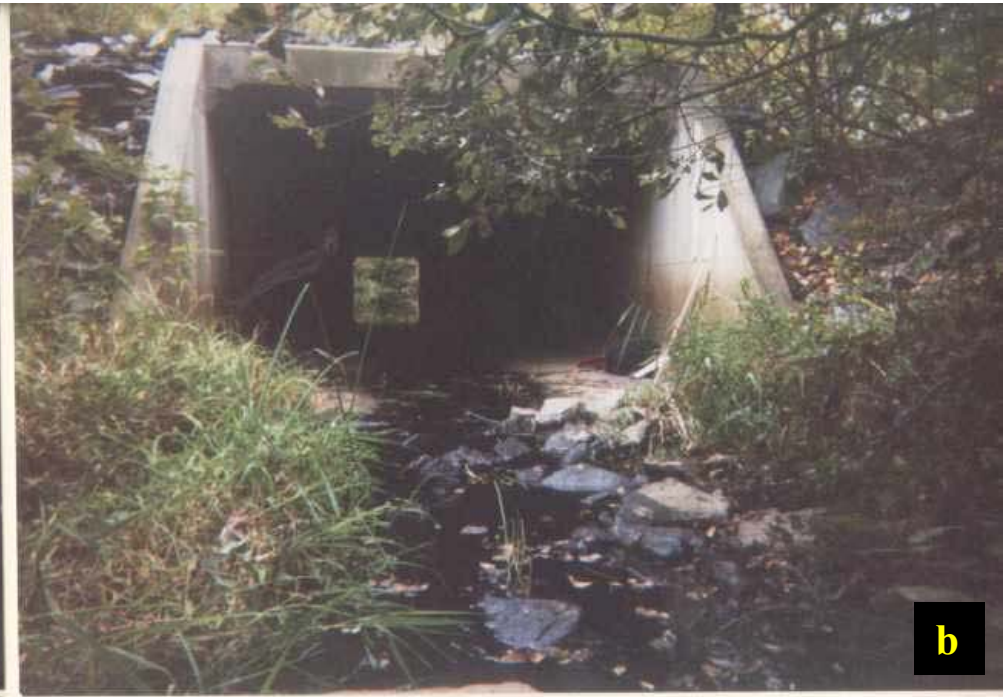
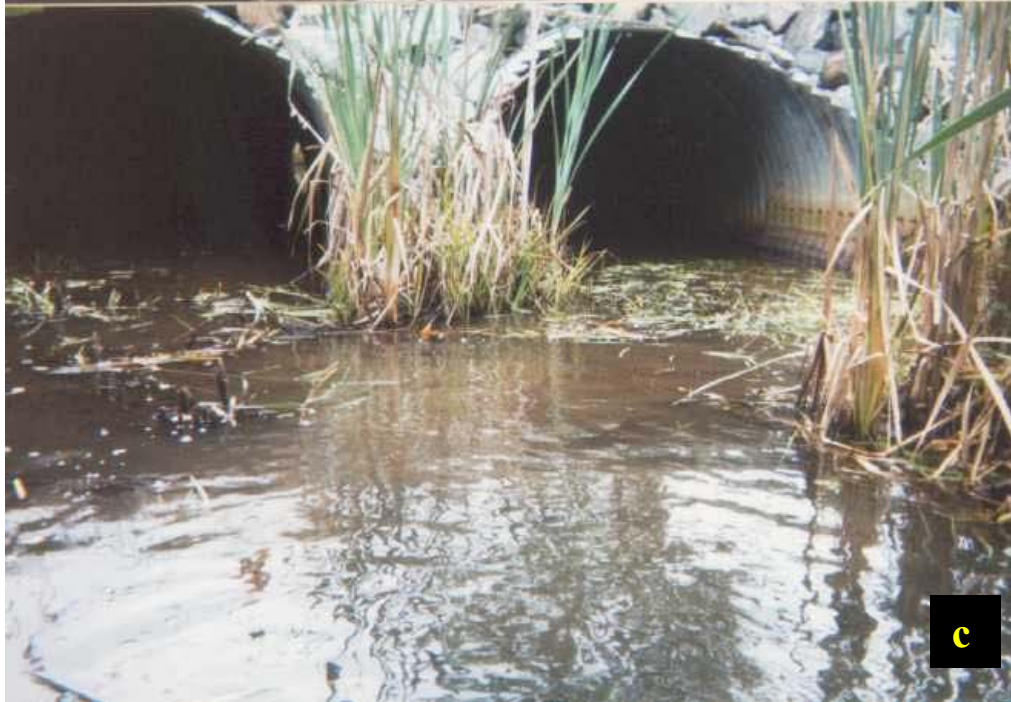
Appendix L-21. Pre-storm culvert photographs taken on 9/25/01 for the third stormwater monitoring event: a) LC-M, b) LC-S, and c) RB. LC-N photo not available.

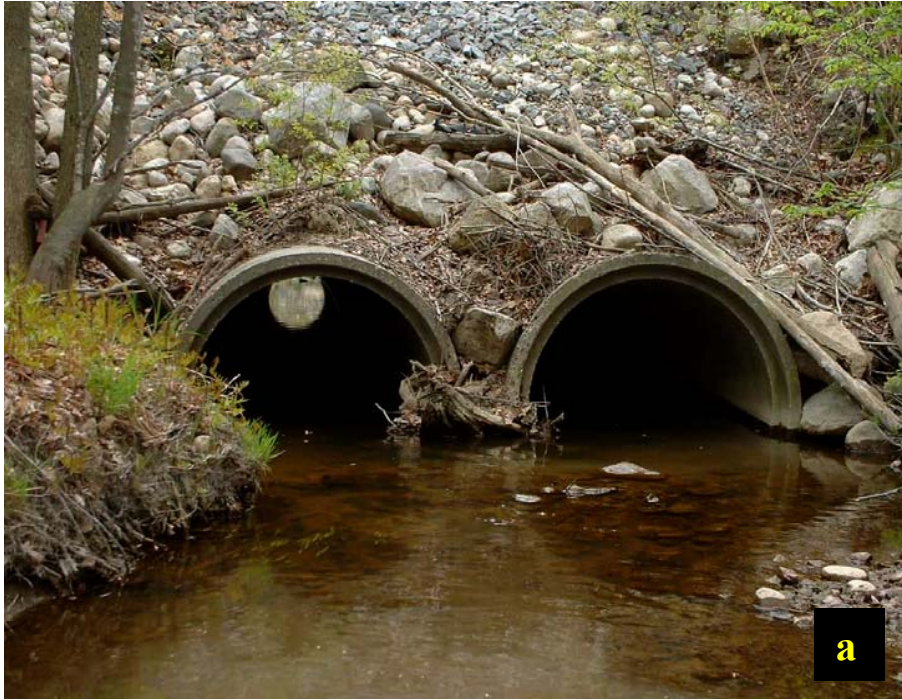
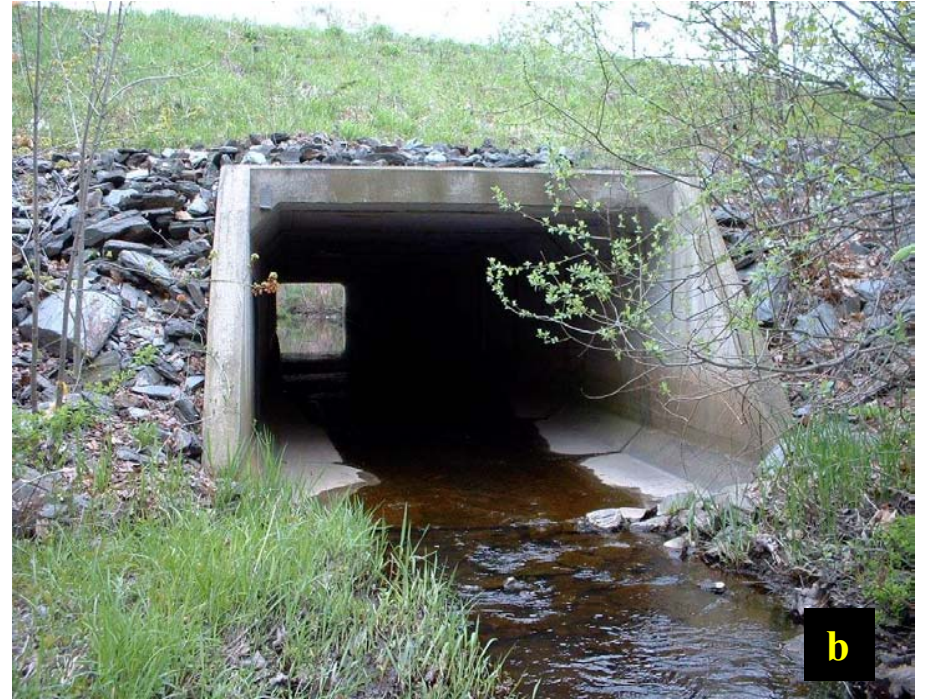
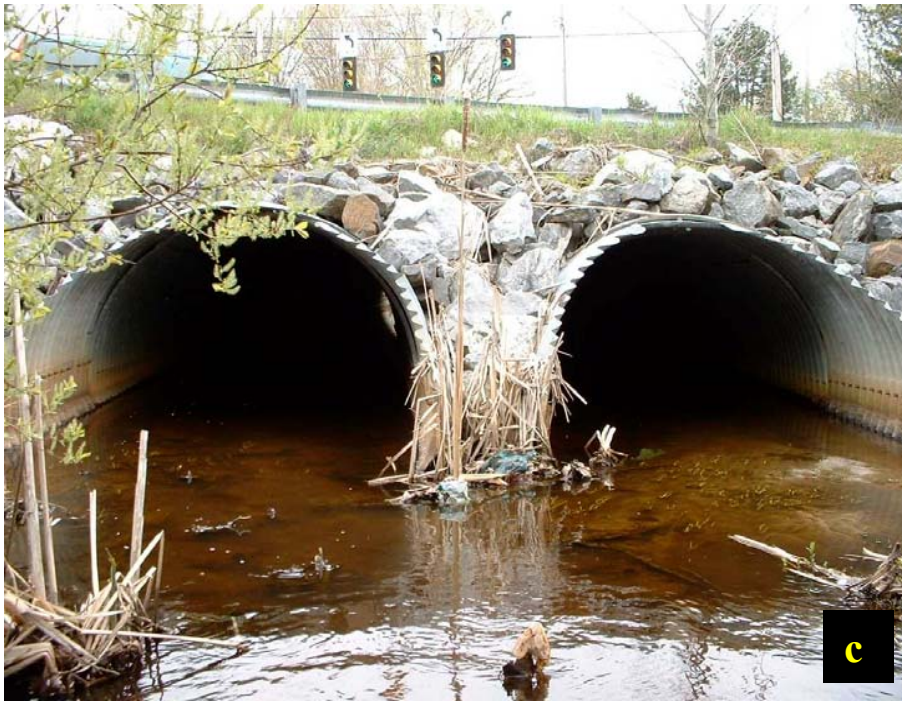
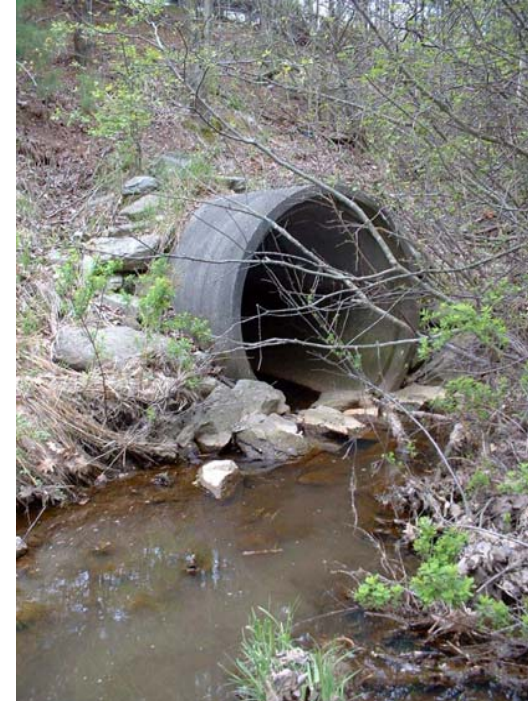
Appendix L-22. Pre-storm culvert photographs taken on 5/13/02 for the second stormwater monitoring event: a) LC-M, b) LC-S, c) RB, and d) LC-N.
